SERMA TECHNOLOGIES

**HAMAMATSU PHOTODIODES (DPD-S8576)
EVALUATION REPORT
(GLAST Project)
REPORT E01P1435 - JUNE 2002**

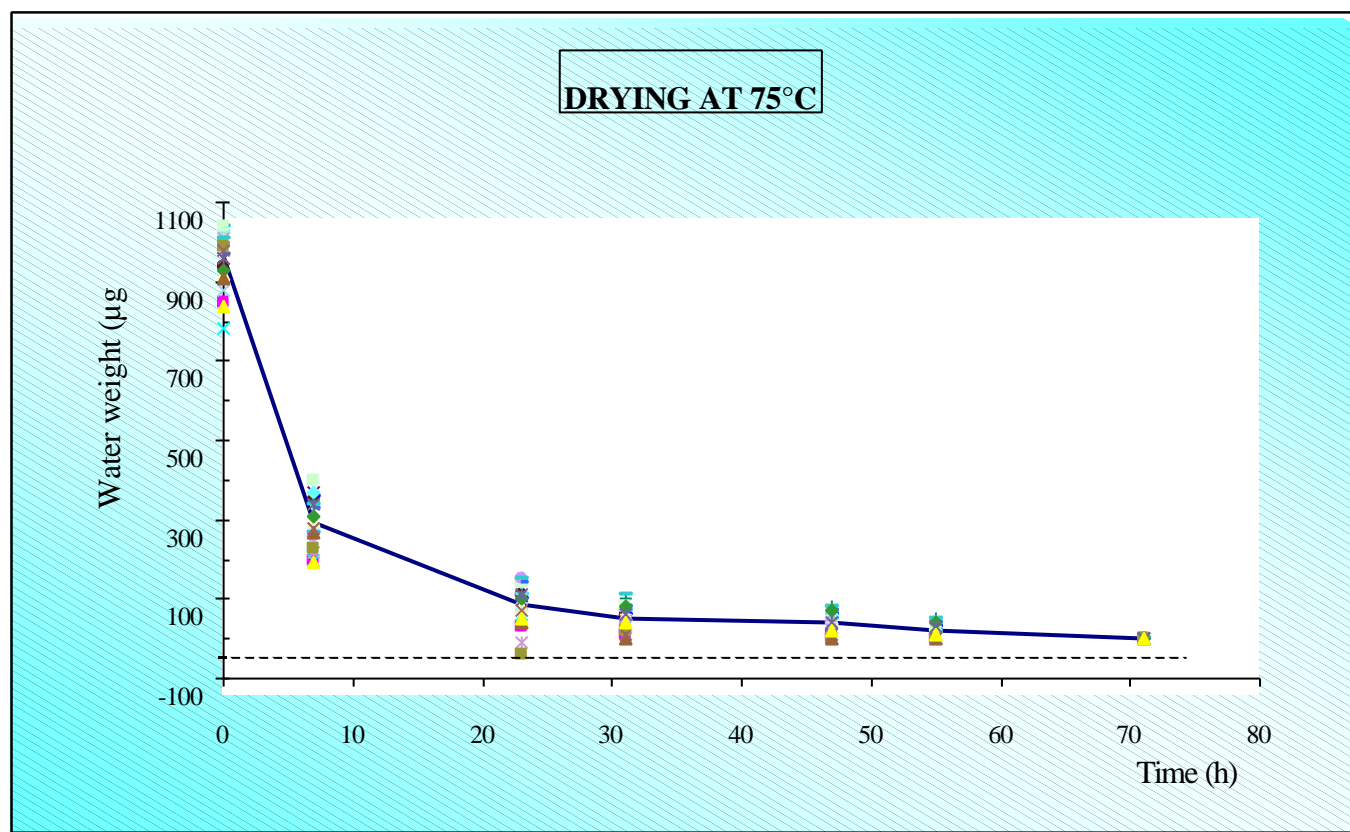
After acoustic microscopy, 71 hours drying at 75°C was necessary to remove the humidity inside the components (962µg). This result shows that the components were not completely dry at reception at SERMA.

The mean weight of water removed by the drying (71h at 75°C) is $962\mu\text{g}$.

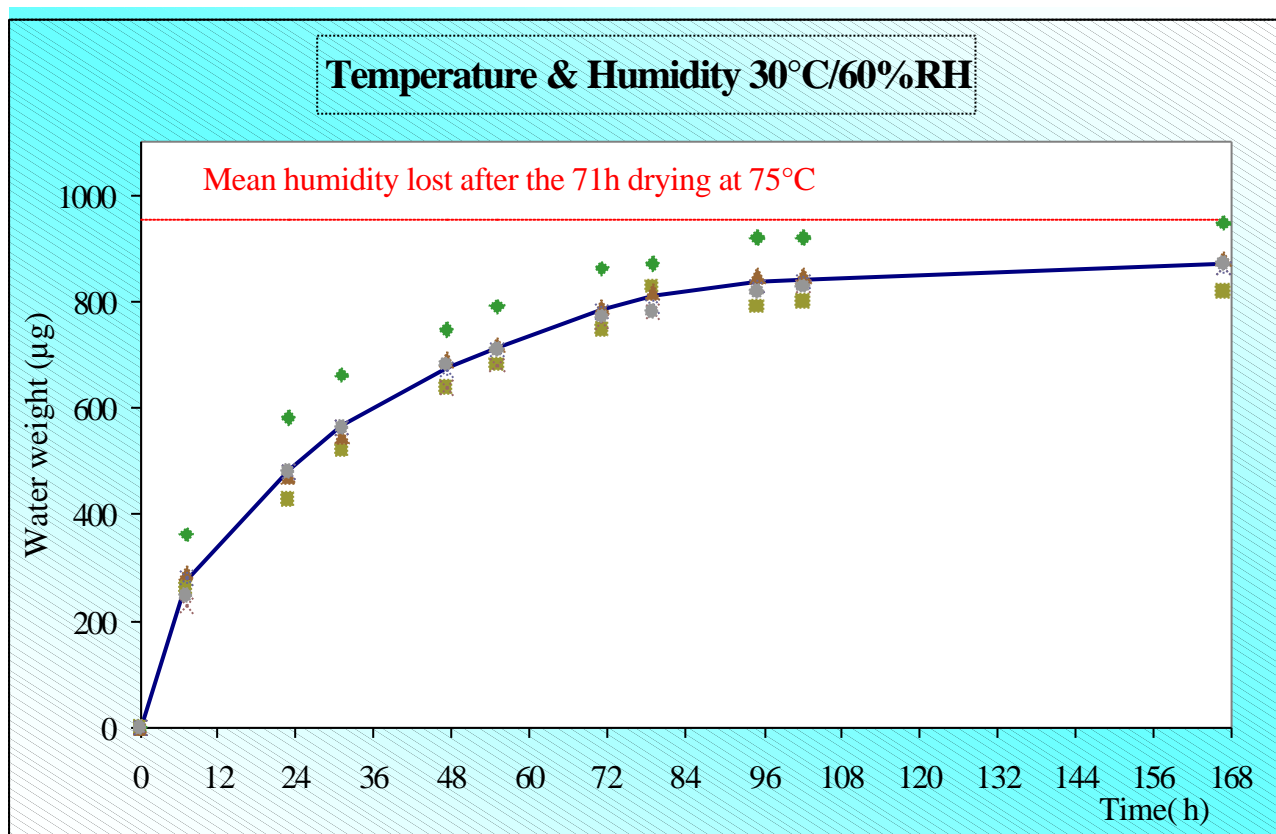
10.1 T&H 30°C / 60%RH

The measurements done show the epoxy resin did not absorb their initial amount of water, in this environment 30°C/ 60%RH: 873 μg after 167h regard to the 962 μg of weight lost after drying of the DPD as arrived at SERMA.

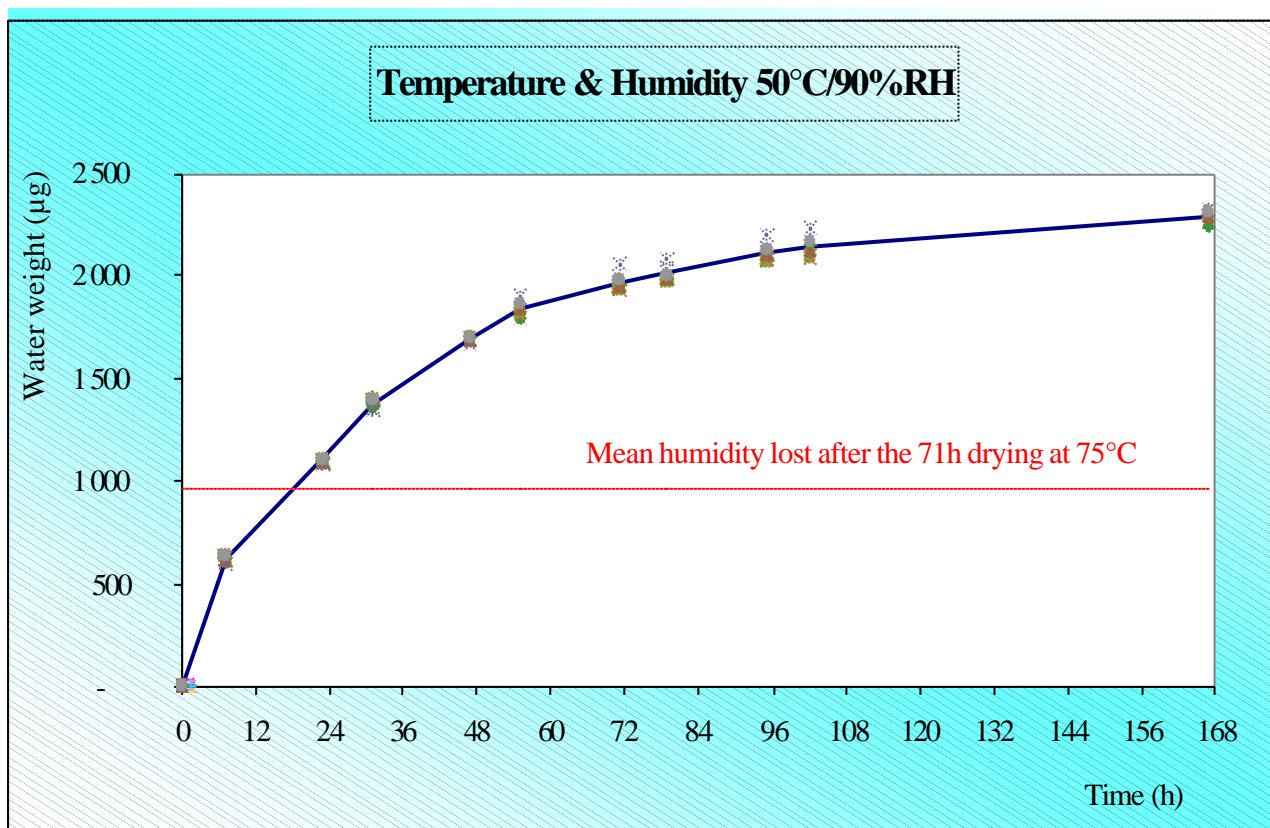
10.2 T&H 50°C / 90%RH

The measurements done show the epoxy resin absorbed their initial amount of water (962 μg) after about 20 hours. In this environment 50°C/ 90%RH, the epoxy resin could absorbed more water about 2300 μg , 2.6 time the one at 30°C/50%RH.

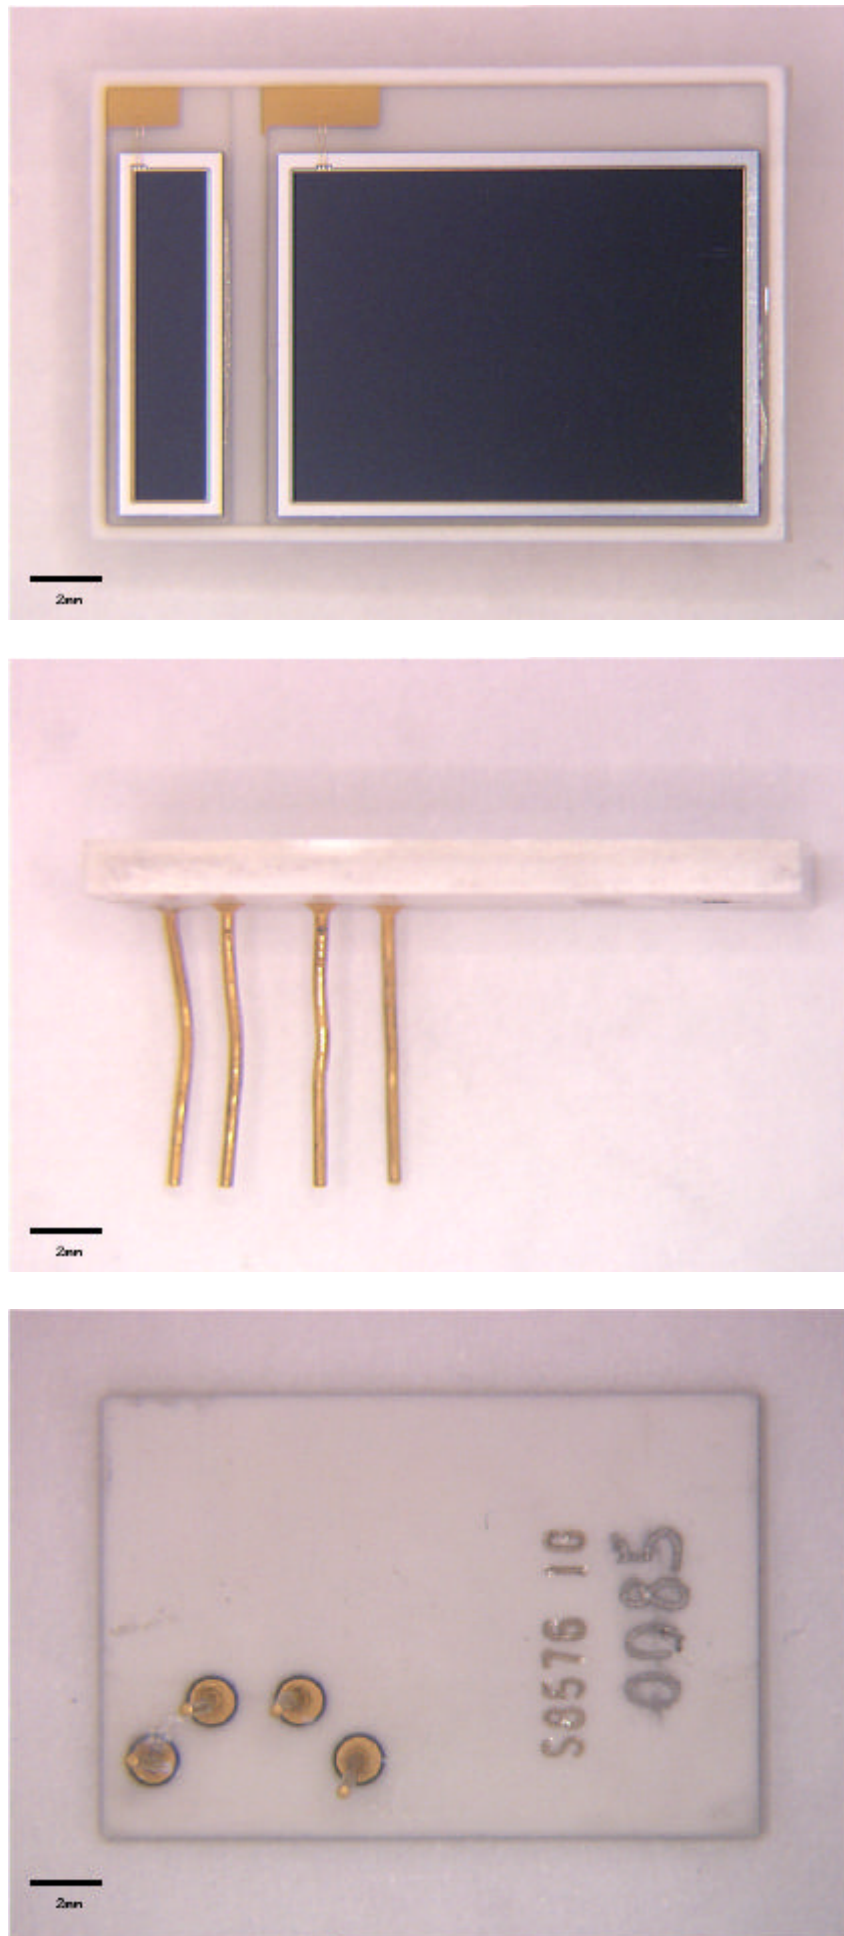
- Two PIN silicon dice are mounted in a ceramic carrier.
- Four gold plated leads are used. The dice are covered with a clear epoxy which fills the ceramic case.
- The studied part was not packaged in flight packaging, toolmarks, bended leads and stains were found. Figures 1 and 2.

Figure 1. External views of the post case, mag $\approx 4X$.

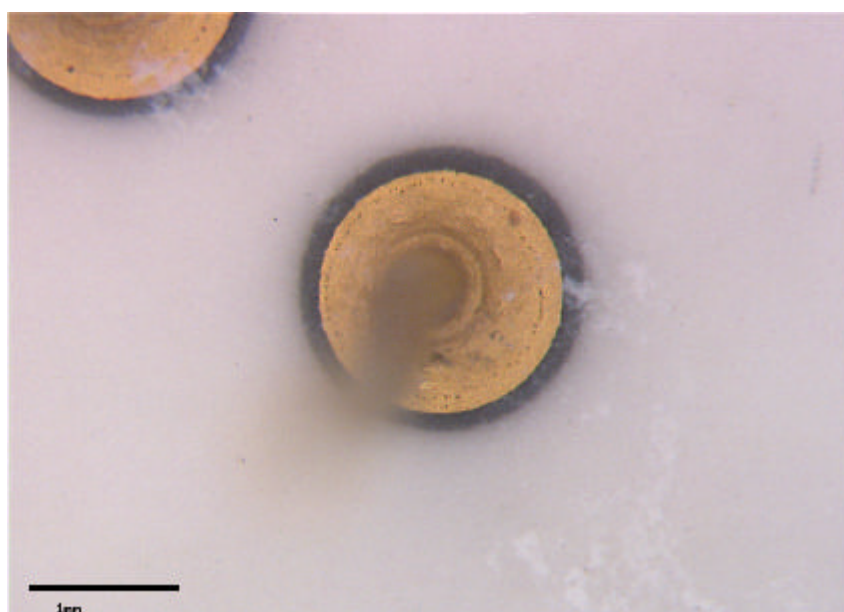
Figure 2. Detail of a lead assembly on the package, mag $\approx 22\times$.

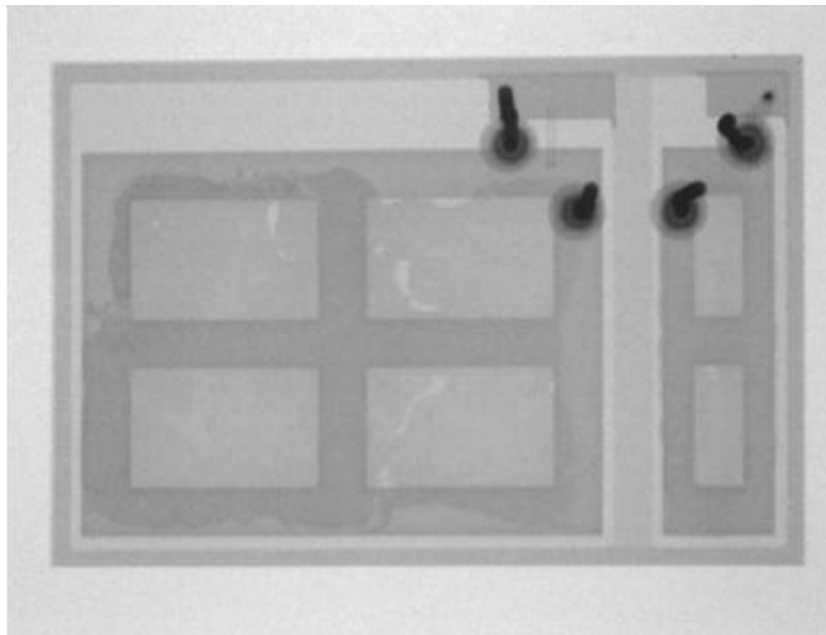
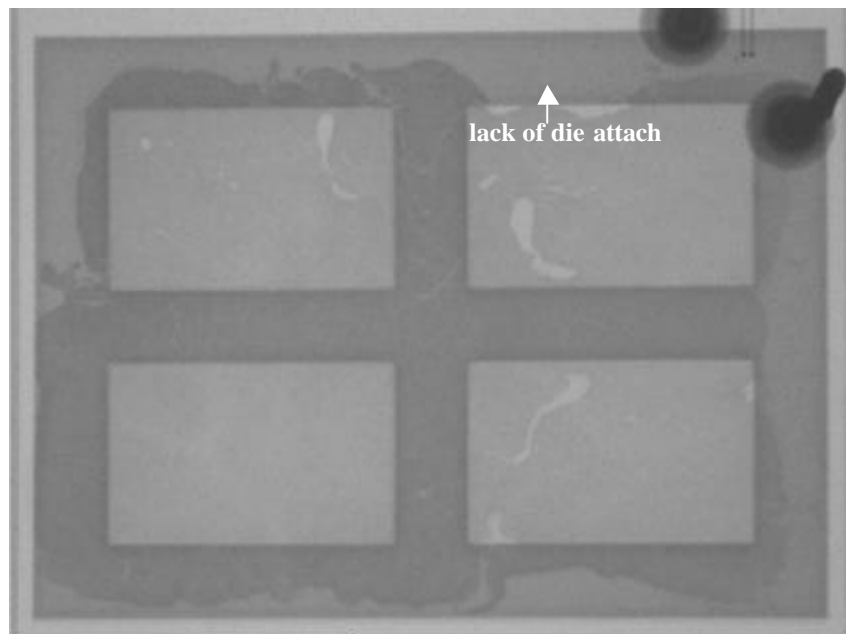
- Top X-rays evidenced lacks of die attach material of diode B (evaluated at 15% of the die surface). They are located at the die periphery. Figure 3.
- The internal connections through gold wires / post / via and external leads are illustrated in Figure 4.

Figure 3. X-rays views of the package and detail of the die B mounting material.

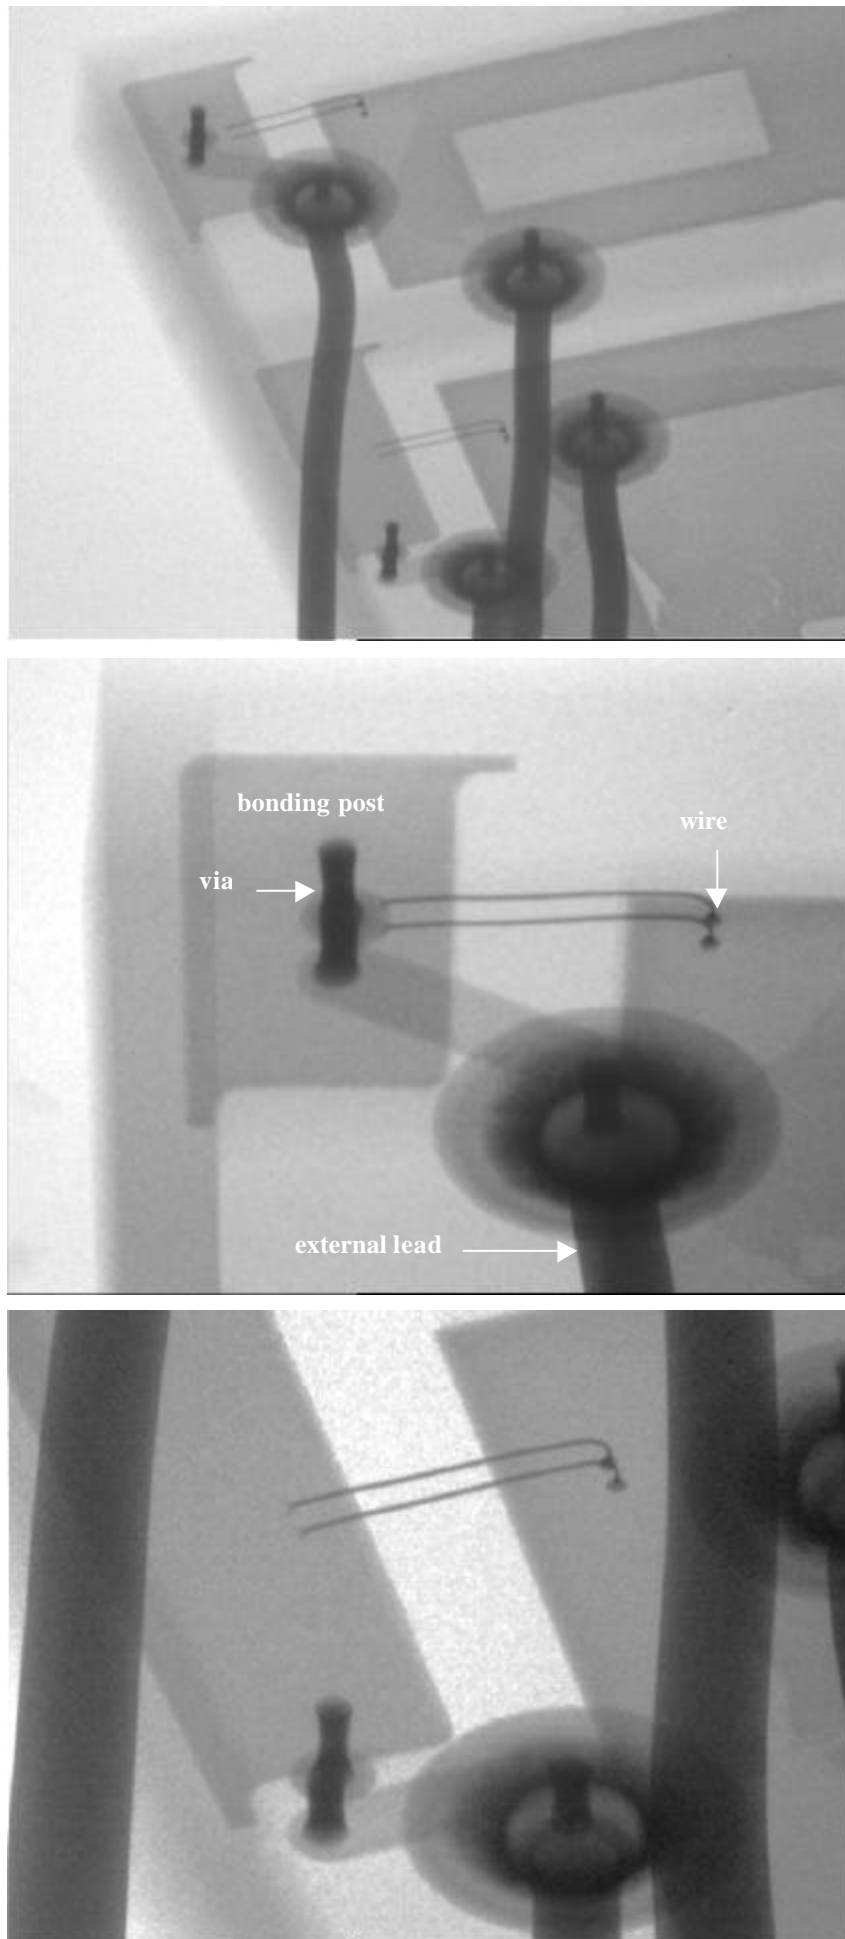
Figure 4. Tilted X-rays views of the internal connections.

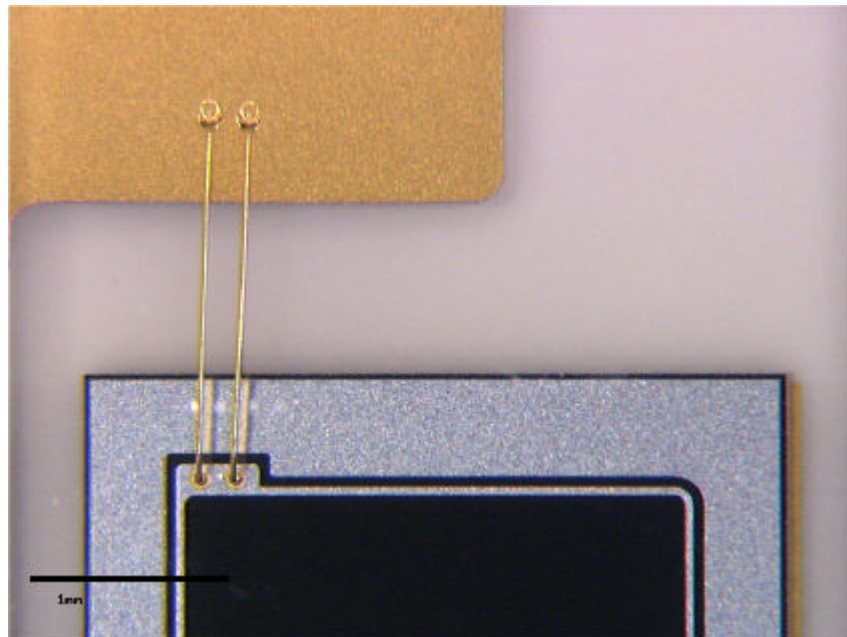
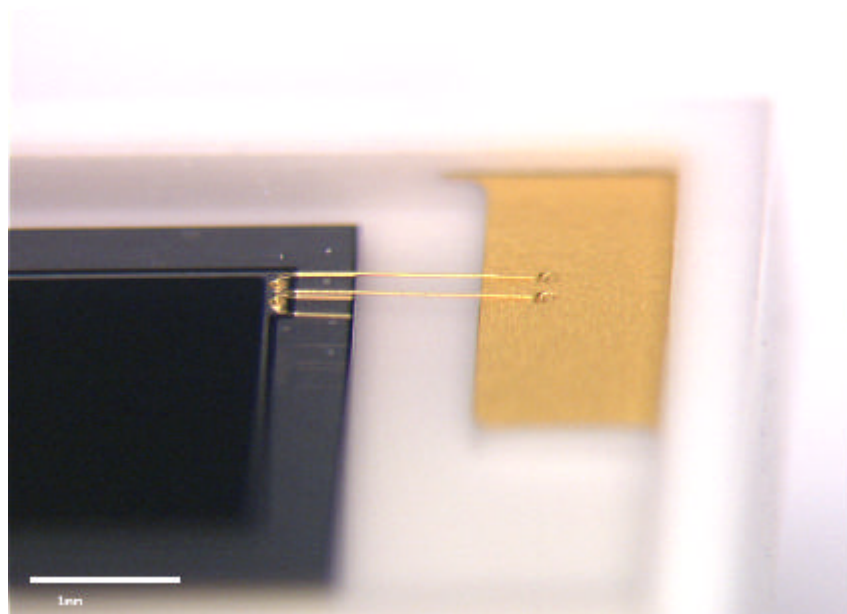
- Each die is connected by two gold bonding wires on a bonding post.
- The component was cut in 3 parts to perform internal inspection, crossection and Tg measurement. Several acids and solvents were used to remove the clear resin. The bonding wires could not be kept intact because of stress applied during resin dissolution. Figures 5 and 6.
- Die dicing is by 100% sawing ; no significant chipout was found on die edges.

Figure 5. Details of the bonding wires through the clear resin.
 Top : mag $\approx 28X$; bottom : mag $22X$.

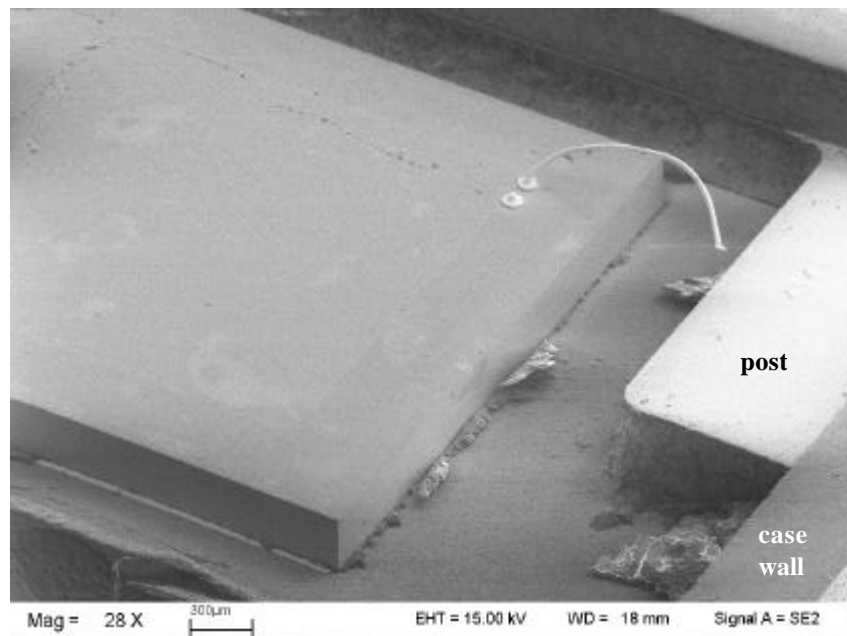
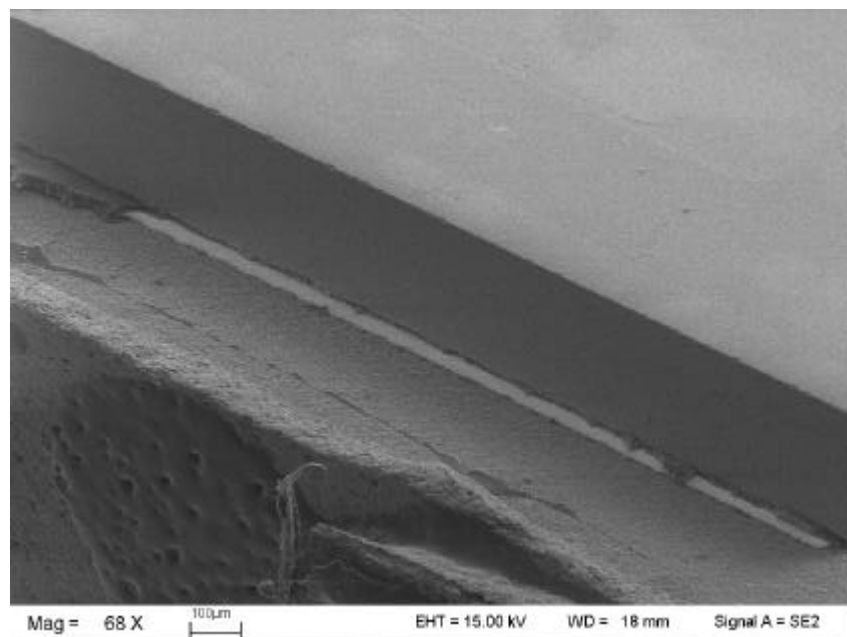
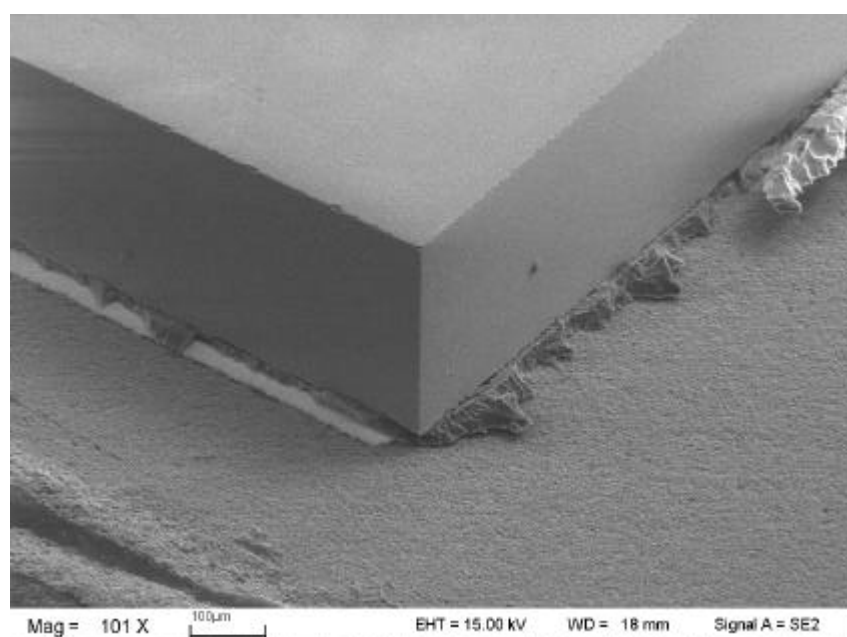
Figure 6. SEM details of die A assembly and dicing.
Top : mag 28X ; center : mag 68X ; bottom : mag 101X.

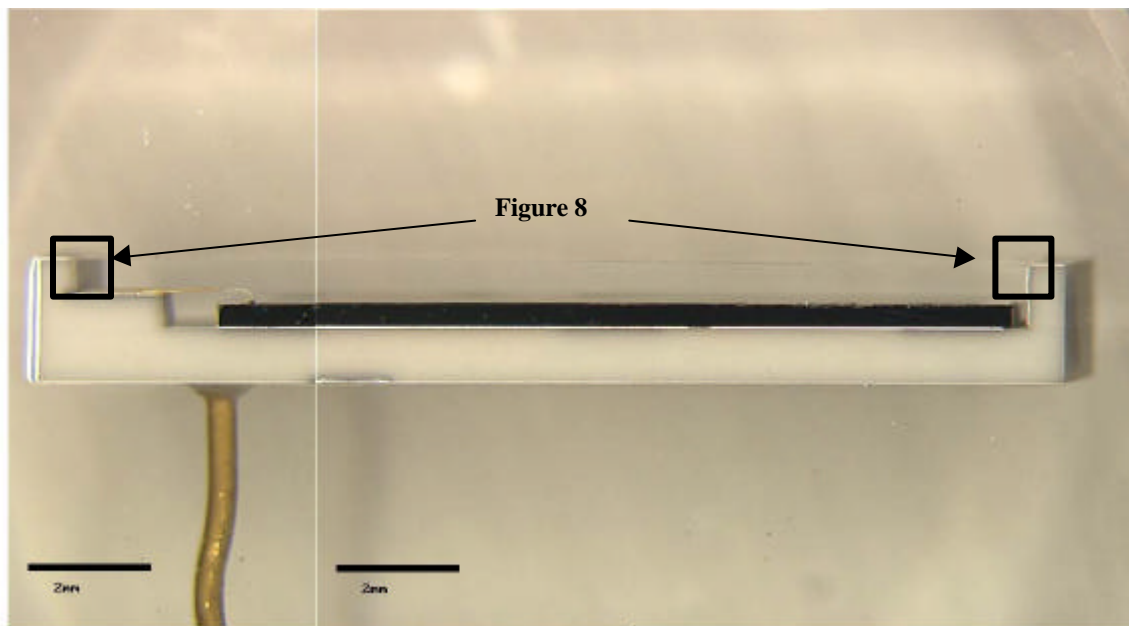
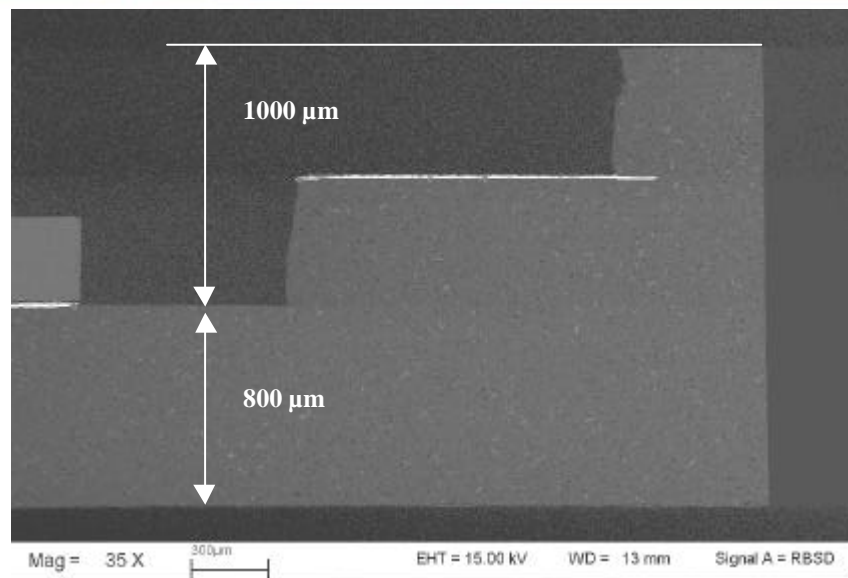
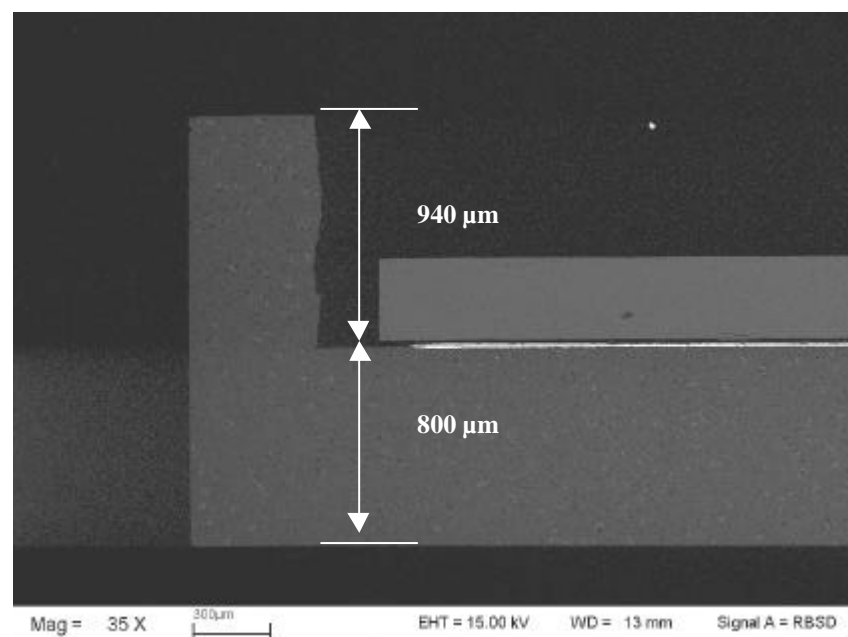
- We found a height difference between two opposite case sides and opposite walls ($\approx 60 \mu\text{m}$). Figure 7.
- The internal via is made by a W compound connecting bottom case level to external level. Figures 9 and 10. The internal layer is only W compound made. The ceramic is an alumina (Al_2O_3), Zr phases were detected. Figure 10.

Figure 7. Optical and SEM views in section of the package.
Top : mag $\approx 9X$; center and bottom : mag 35X.

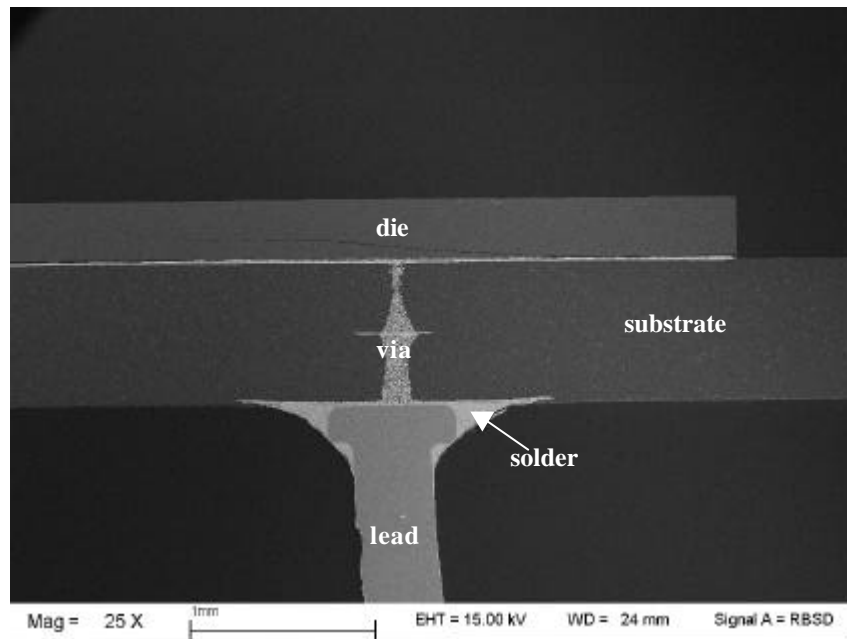
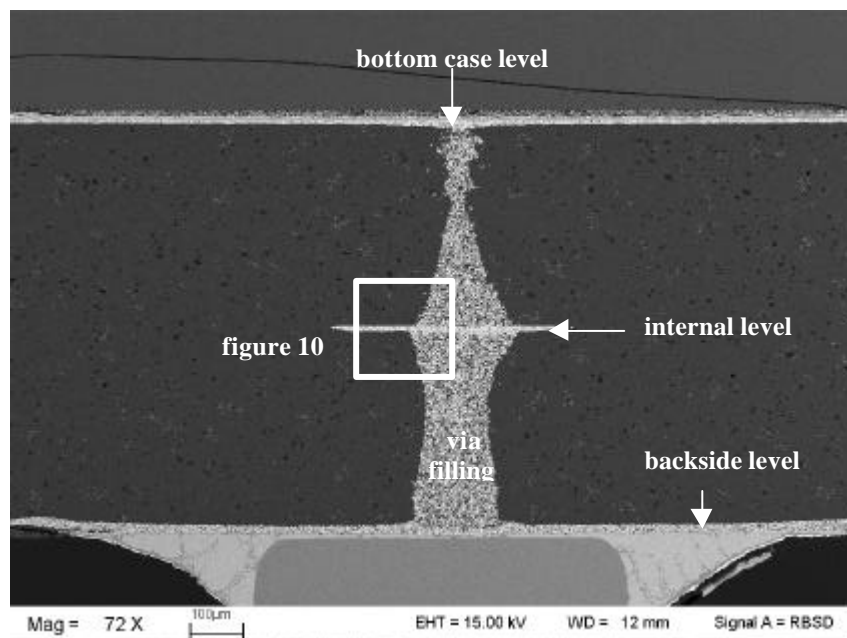
- General views of the package in section are shown in Figure 7.
- The ceramic carrier is multilayered. Top metallization level for package bonding post, one level is used for case bottom (die bonding level) ; one level is used for internal level, last one is used on case backside at lead soldering area, Figure 9.

Figure 9. SEM views in section of internal via connection.
Top : mag 25X ; bottom : mag 72X.

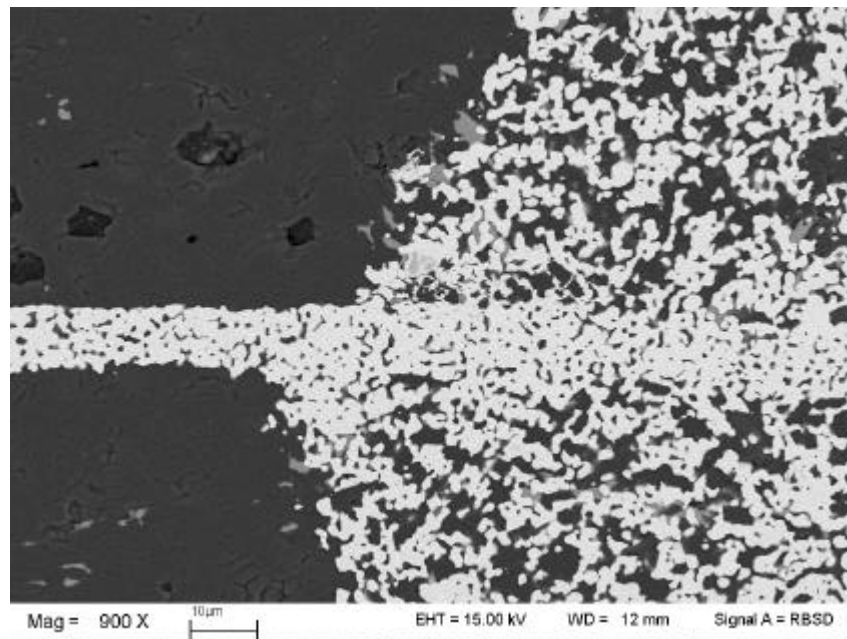
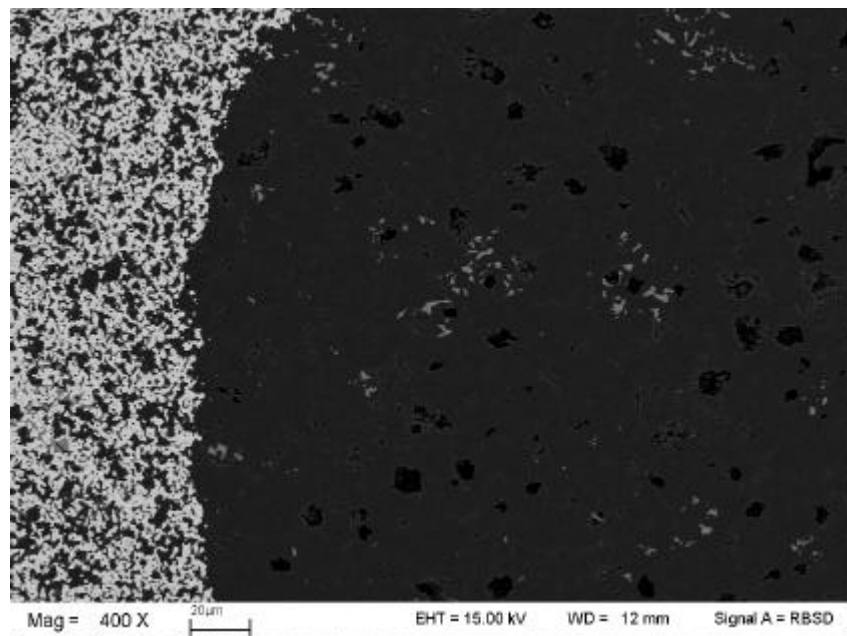
Figure 10. SEM views of internal layer, ceramic and via filling.
Top : mag 900X ; bottom : mag 400X.

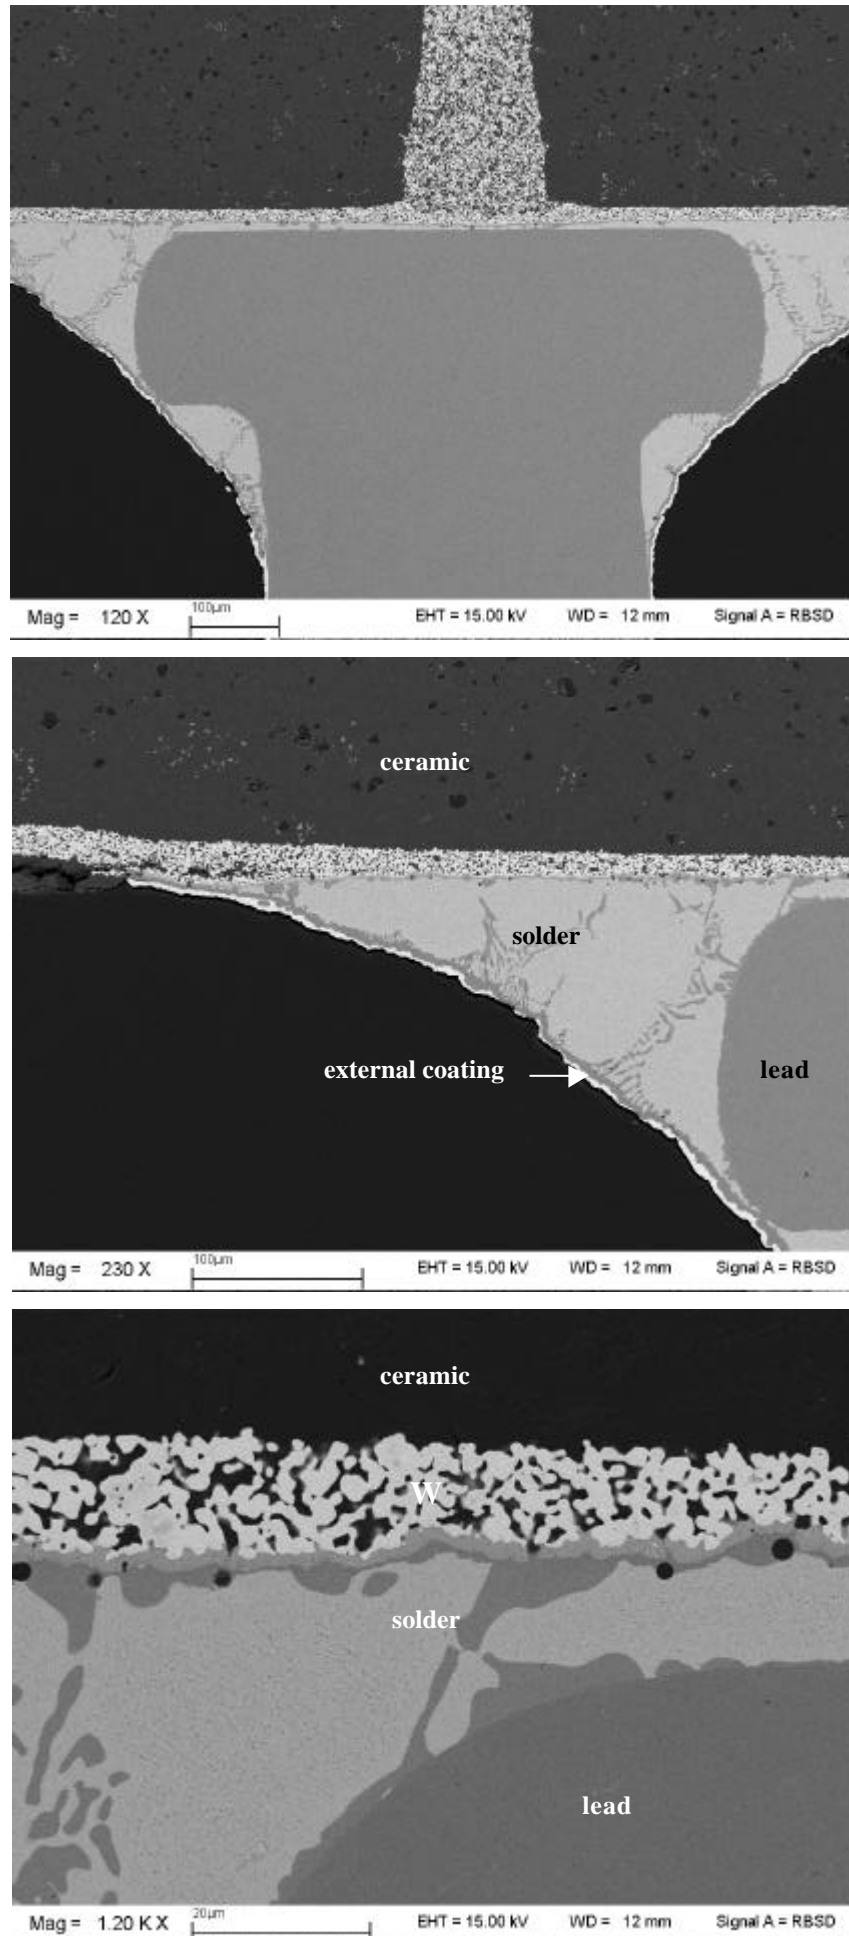
- The FeNi lead is soldered to the case by an AgCu solder. Figures 11 and 12. The lead and solder are covered by NiP / Au layers.
- Internal connections are performed by two Au wires per die. The interfaces observed in section on die and bonding post did not evidenced anomaly. Figure 13.

Figure 11. Details of lead soldering.

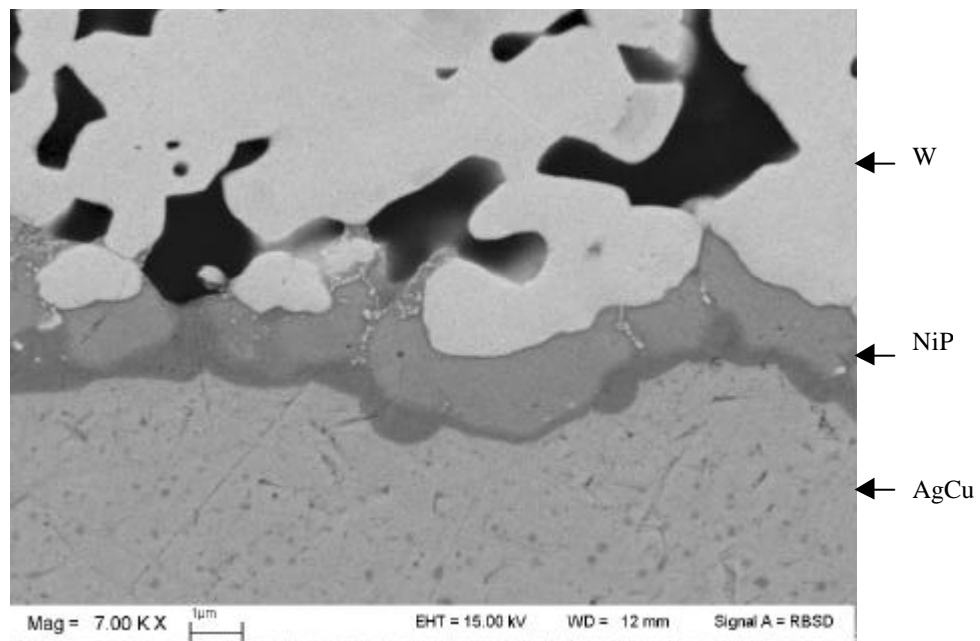
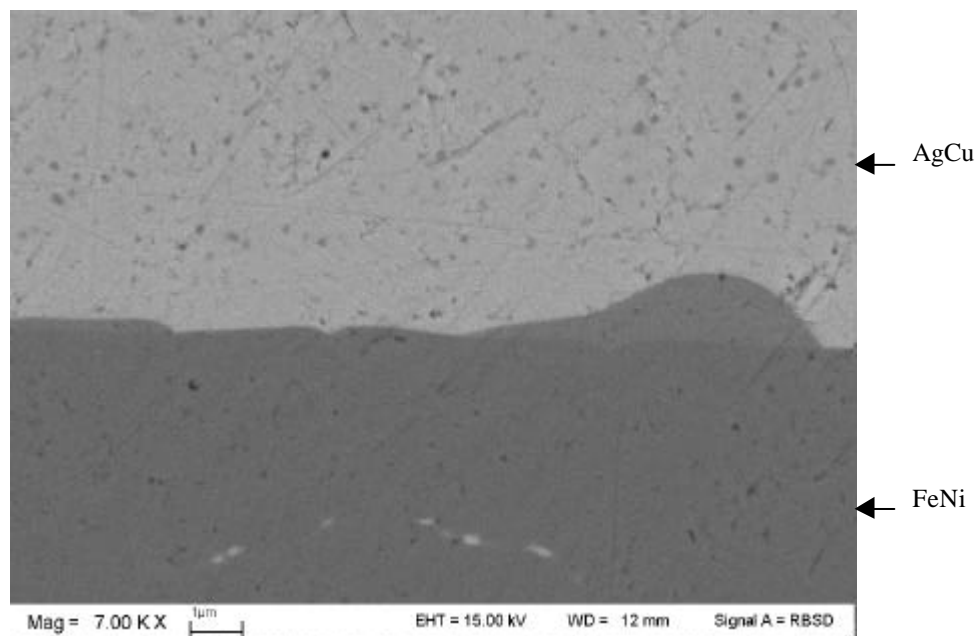
Figure 12. SEM details of lead soldering, mag 7000X.

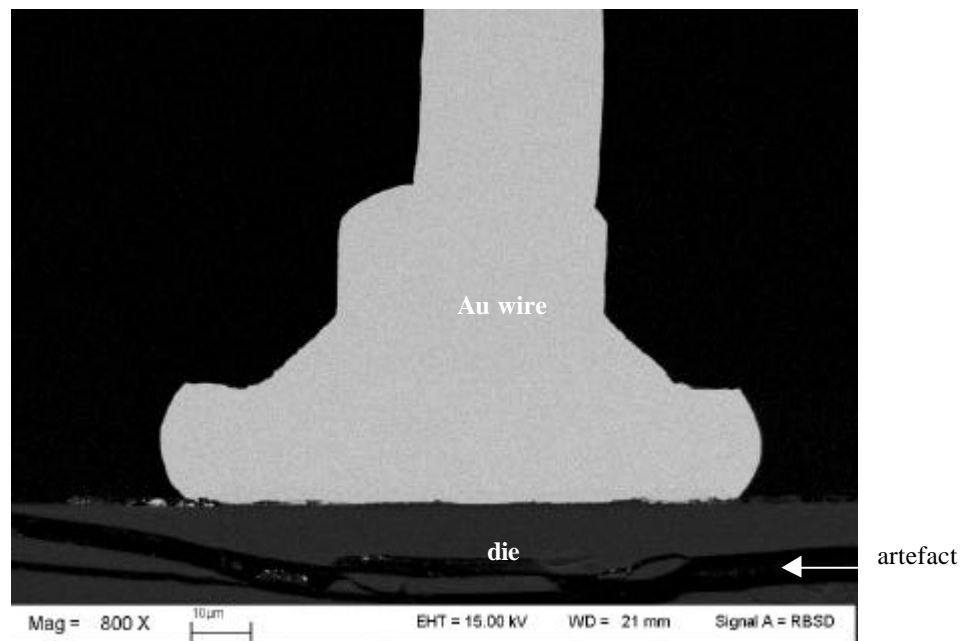
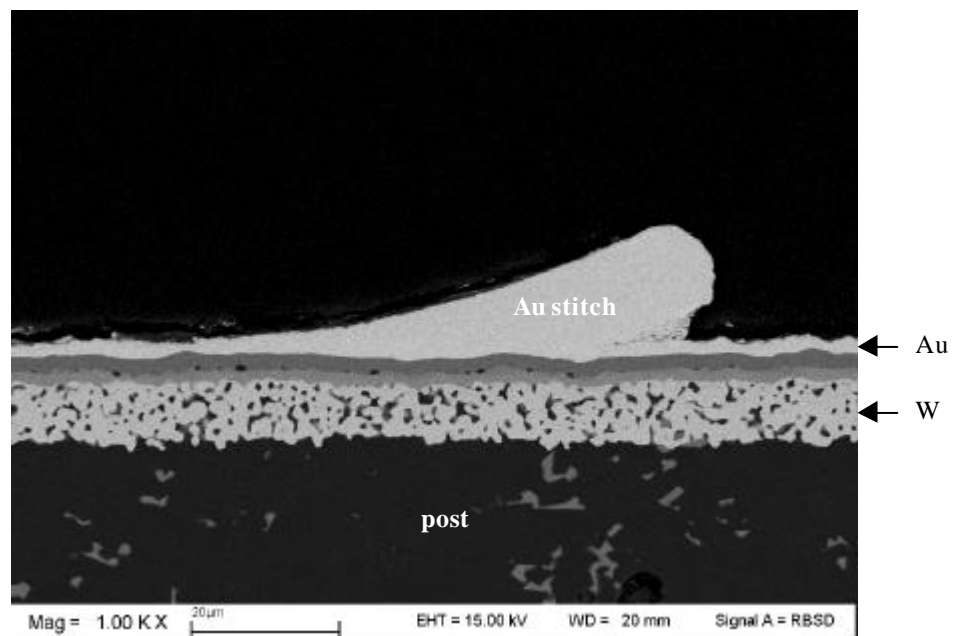
Figure 13. SEM details in section of ball and stitch bond.
Top : mag 800X ; bottom : mag 1000X.

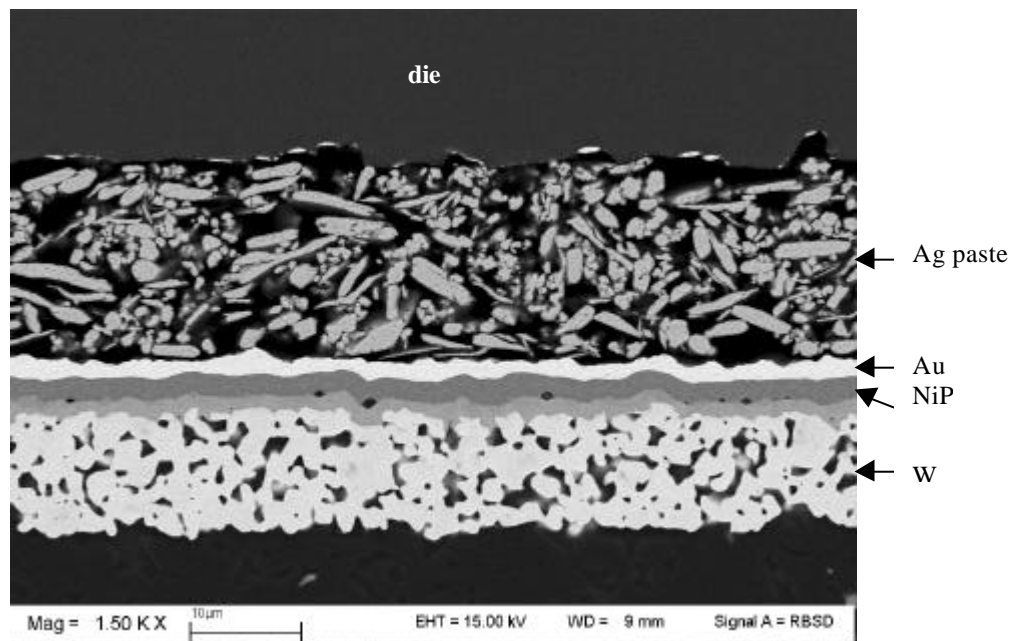
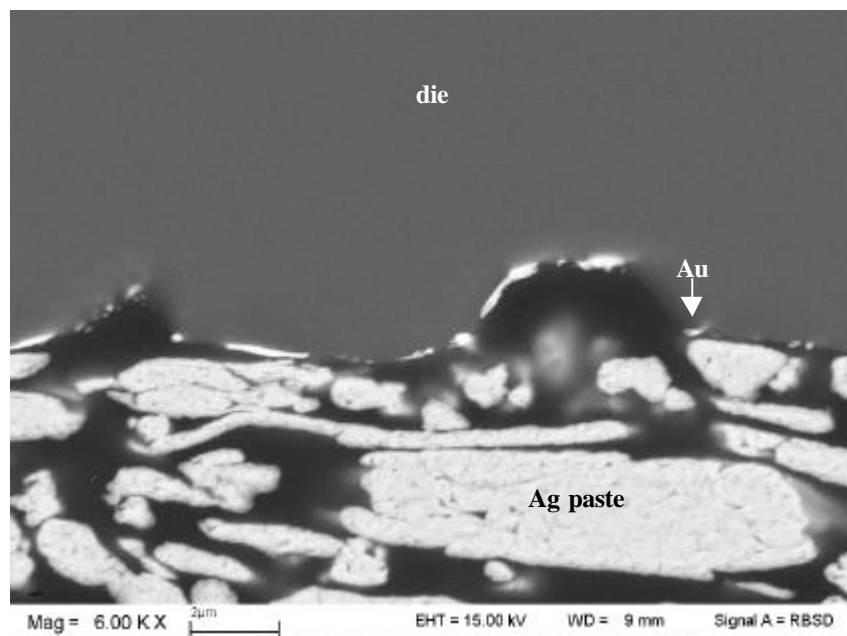
- The die is bonded on the case bottom by an Ag paste on the Au / NiP / W metallization. The interfaces were correct. Die backside is metallised with a gold layer. Figure 14.

Figure 14. SEM views in section of die attach material and die backside metallization.
Top : mag 1500X ; bottom : mag 6000X.

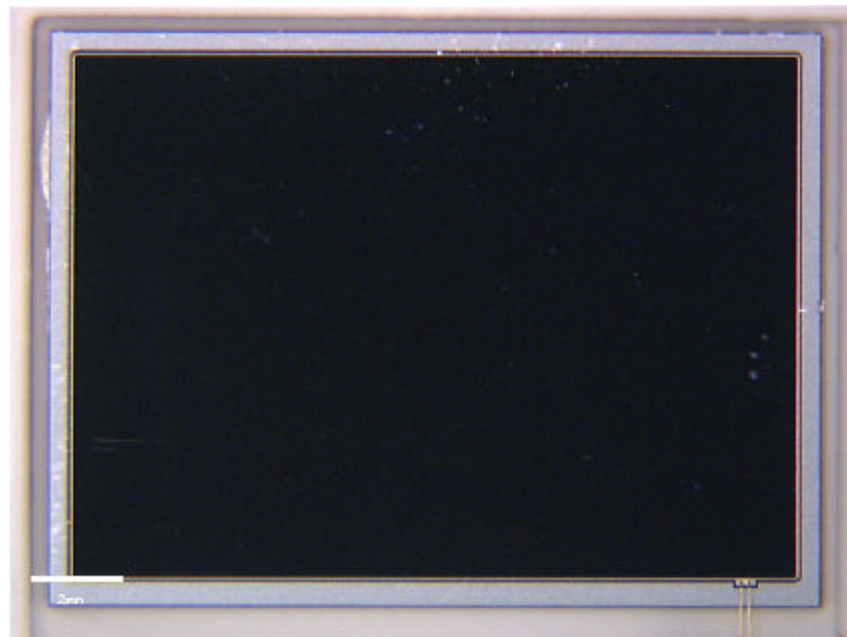
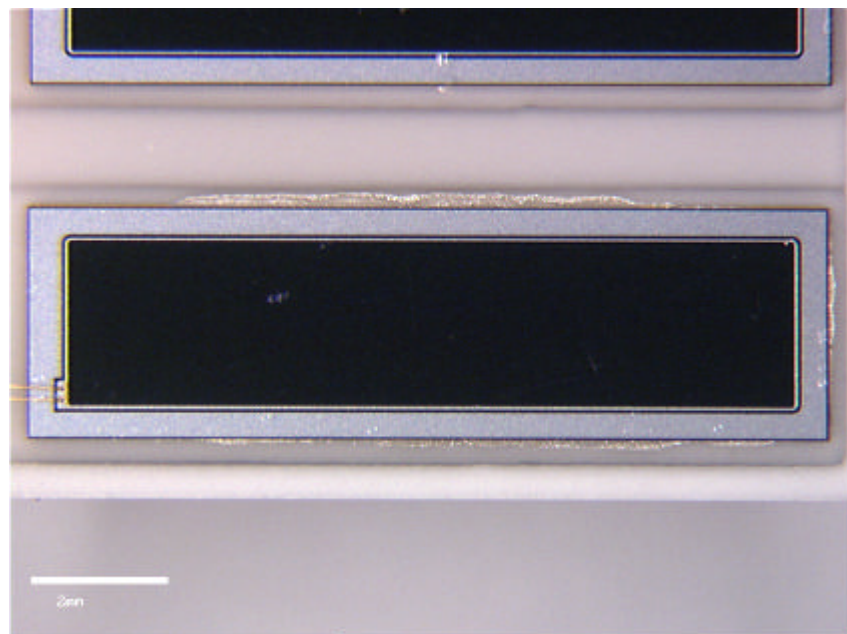
- Views of the dice are shown in Figure 15.
- The dice are silicon PIN diodes. A peripheric aluminum ring contacts the die. The sensitive area uses the most surface of the die. Figure 16.
- Details of the contact area (aluminum etched) are shown in Figure 16. Section views of the die B are shown in Figures 17 and 20.
- The die is contacted by aluminum lines on diffusions.
- The sensitive layer is covered by a thin silicon nitride over a P+ diffusion.

Figure 15. General views of the dice.
Top : mag $\approx 7X$; bottom : mag $\approx 10X$.
